RECALL CAMPAIGN BULLETIN

NTB08-095c

December 4, 2008

VOLUNTARY RECALL CAMPAIGN 2007 – 2009 PASSENGER AIR BAG OCCUPANT CLASSIFICATION SYSTEM (OCS)

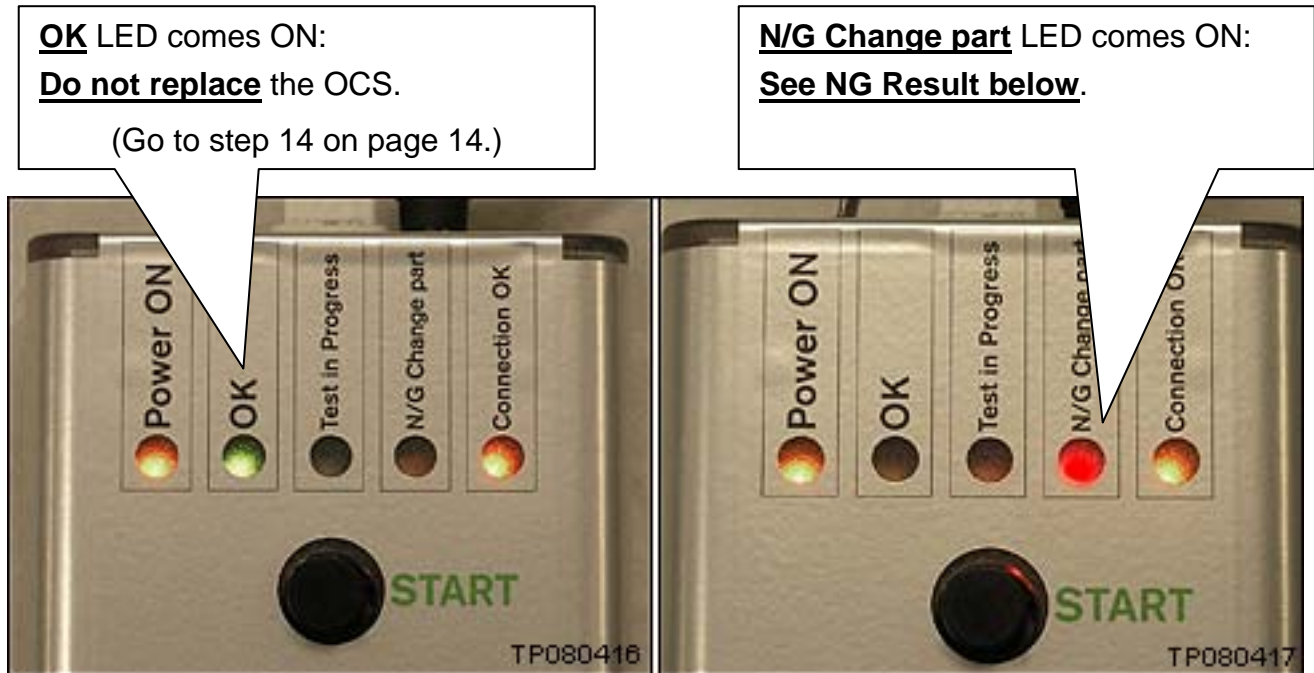
Figure 7

NOTE: Expected results - **Less than 1% will test NG.** More than 99% will test OK.

NG results:

NG results are expected to be very low (less than 1% of vehicles tested).

- a. Remove / disconnect both ends of the MAT cable that you are using.
- b. Get another serviceable new MAT cable and connect it to the Varistor Test Tool and the vehicle seat.
 - Make sure to mark the usage card for each MAT cable connection.
- c. Repeat the OCS inspection test (steps 9 though 13).
- d. After repeating the test with a second MAT cable (NG result 2 times), replace the OCS / seat cushion.
 - See OCS / seat cushion replacement on the next page.

- If the second test is a NG result (same as the first), the original cable can continue to be used for the remainder of its “usage card” life.
- If the second test is an OK result (different than the first) the original cable should be discarded.
