RECALL CAMPAIGN BULLETIN

NTB08-095c

December 4, 2008

VOLUNTARY RECALL CAMPAIGN 2007 – 2009 PASSENGER AIR BAG OCCUPANT CLASSIFICATION SYSTEM (OCS)

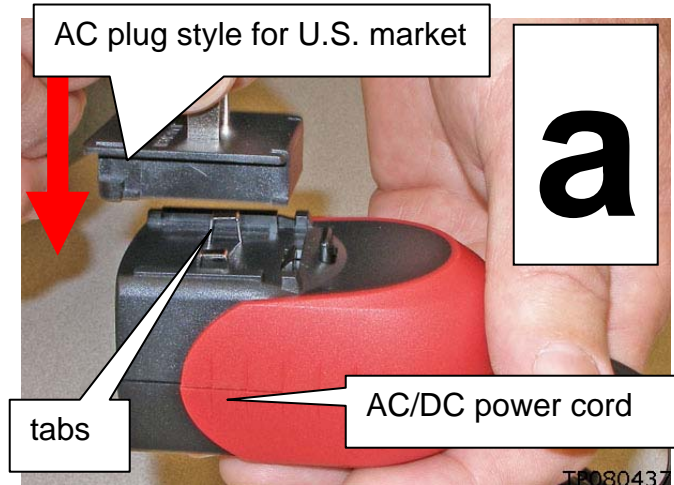
Figure E

- To install the AC plug to the AC/DC Power Cord:
 - Set the plug straight down onto the Power Cord tabs. (see Figure E)
 - Once the adapter is on the tabs, slide the adapter on to lock it in place. (see Figure F)

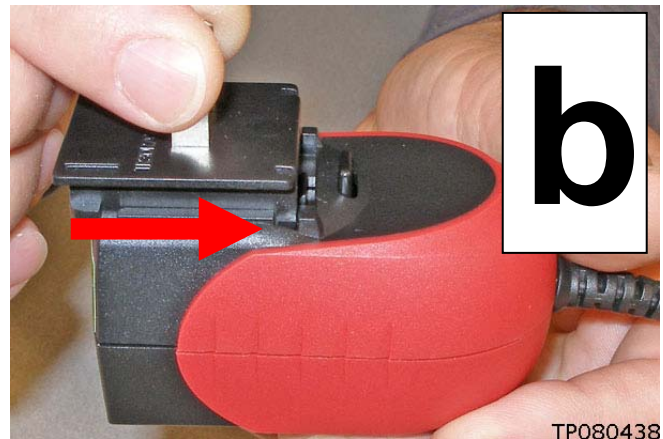
Figure F

DO NOT TRY TO SLIDE THE ADAPTER ONTO THE POWER CORD TABS. THE TABS WILL BREAK IF THIS IS TRIED.

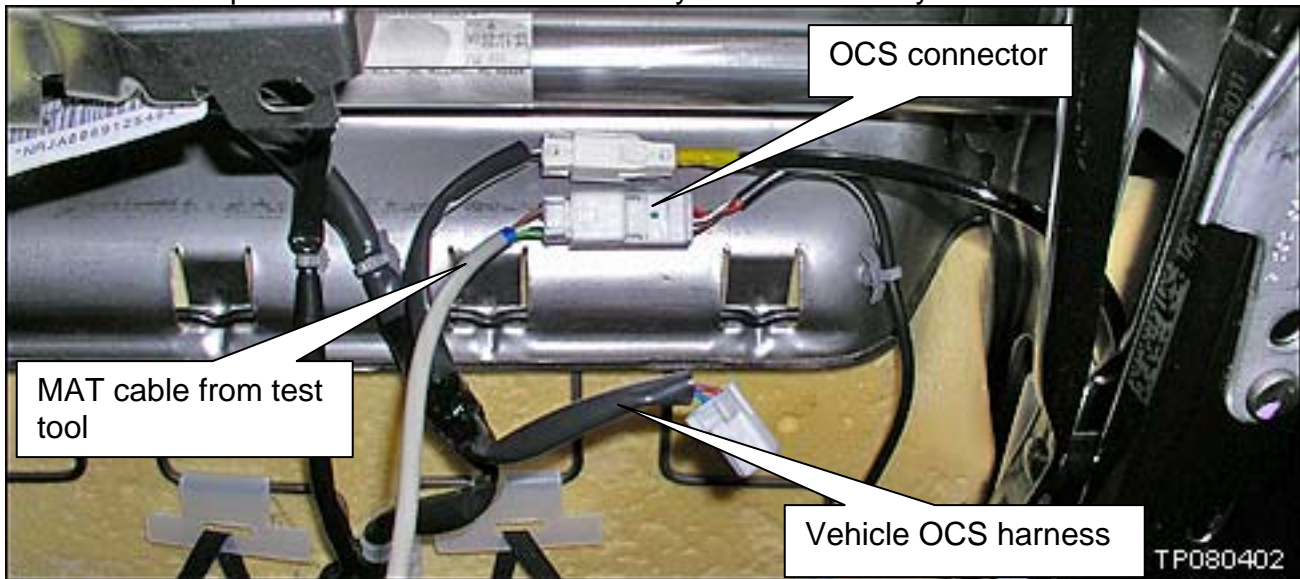
Figure 2

8. Look under the passenger seat; locate and disconnect the OCS connector and connect the MAT cable.

- The OCS connector is an 8 pin white connector (only 3 of the pins are used/filled).

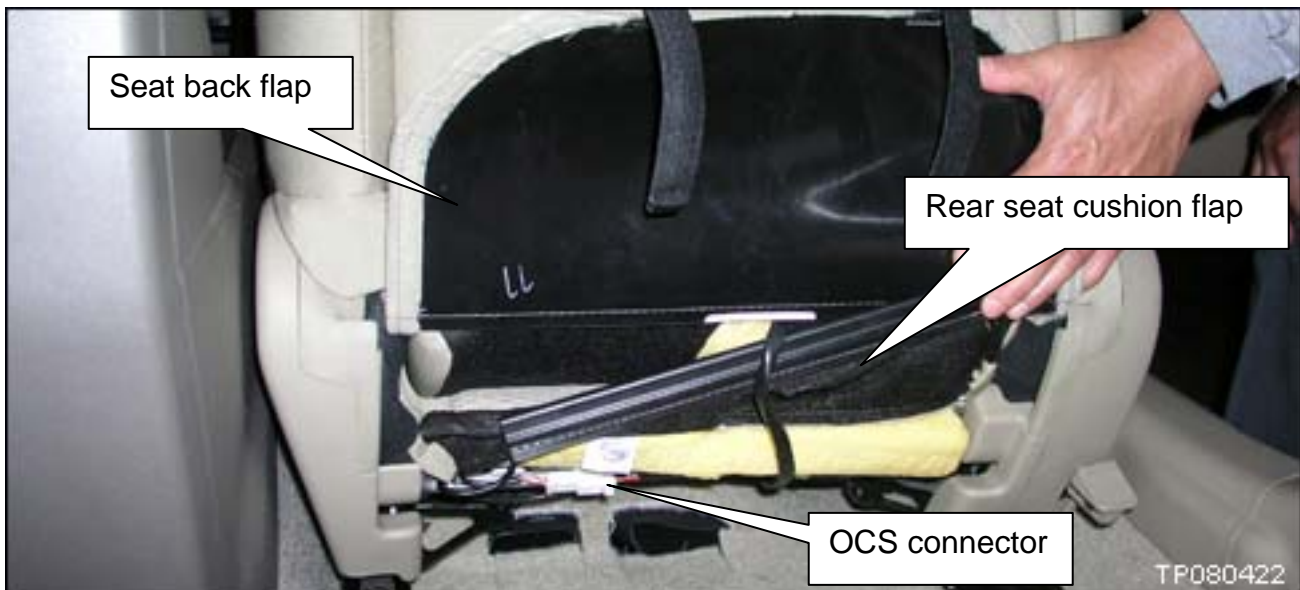
Figure 3

NOTE for Altima Coupe: The OCS connector is located at the rear of the seat cushion.

- Adjust the seat all the way forward; unhook the seat back flap and the rear seat cushion flap.
